Subject: Submittal of the 2018 Monitoring Report for Los Alamos/Pueblo Watershed
Sediment Transport Mitigation Project

1. Two hard copies with electronic files – 2018 Monitoring Report for Los Alamos/Pueblo Watershed Sediment Transport Mitigation Project (EM2019-0106)

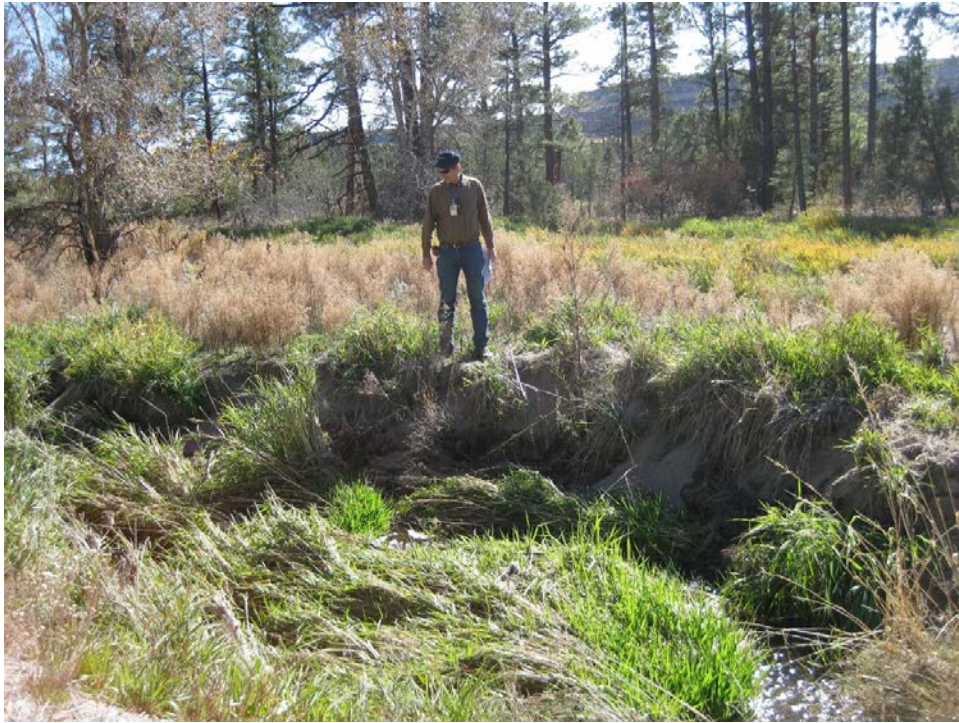
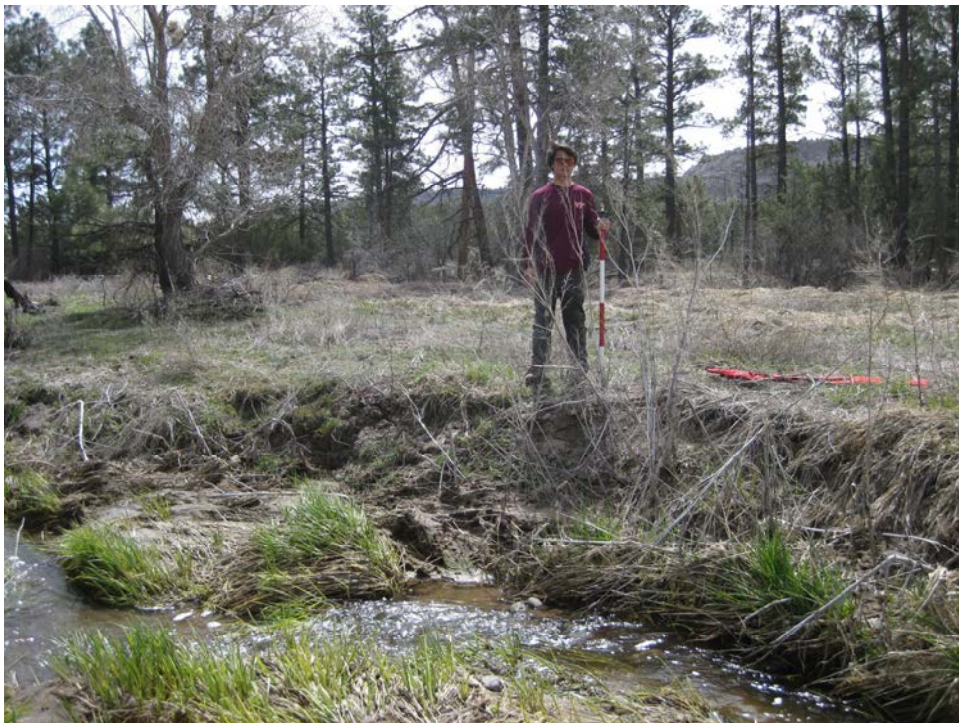
Photo A1-1 Detected erosion (2016) in Pueblo Canyon in (a) November 2017 compared with the same view in (b) March 2019, showing no observable change

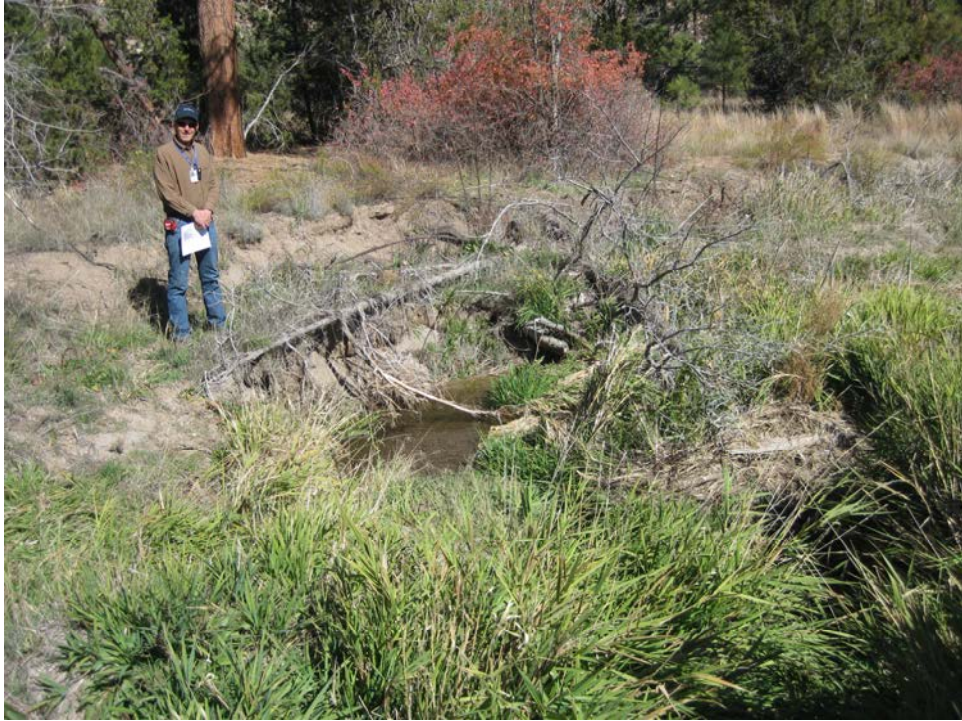
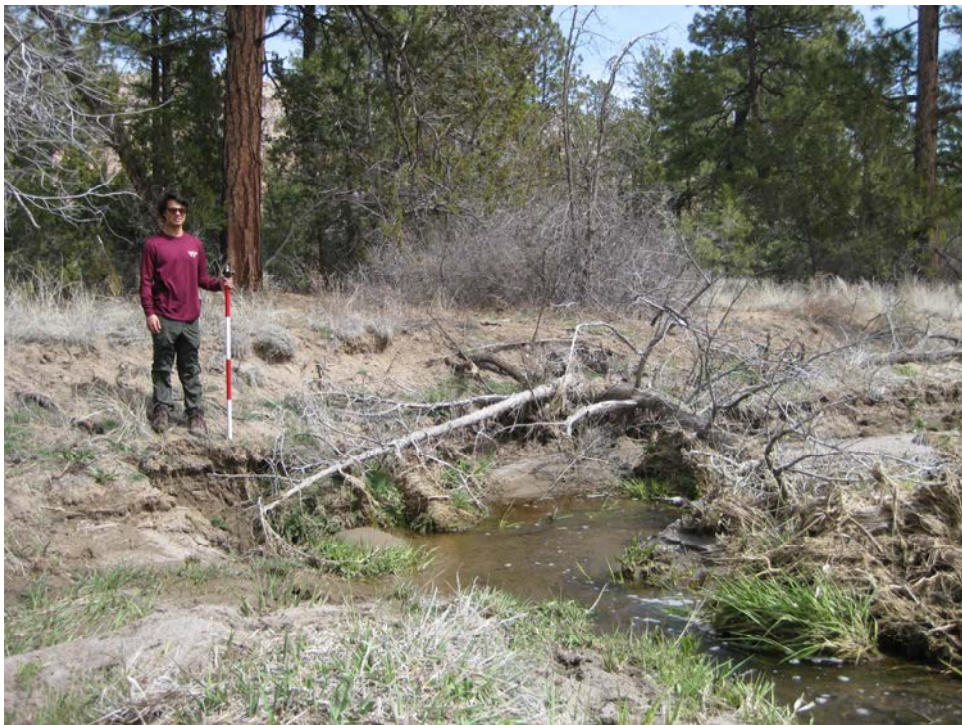
Photo A1-2 Detected erosion (2016) in Pueblo Canyon in (a) November 2017 compared with the same view in (b) March 2019, showing minor observable change

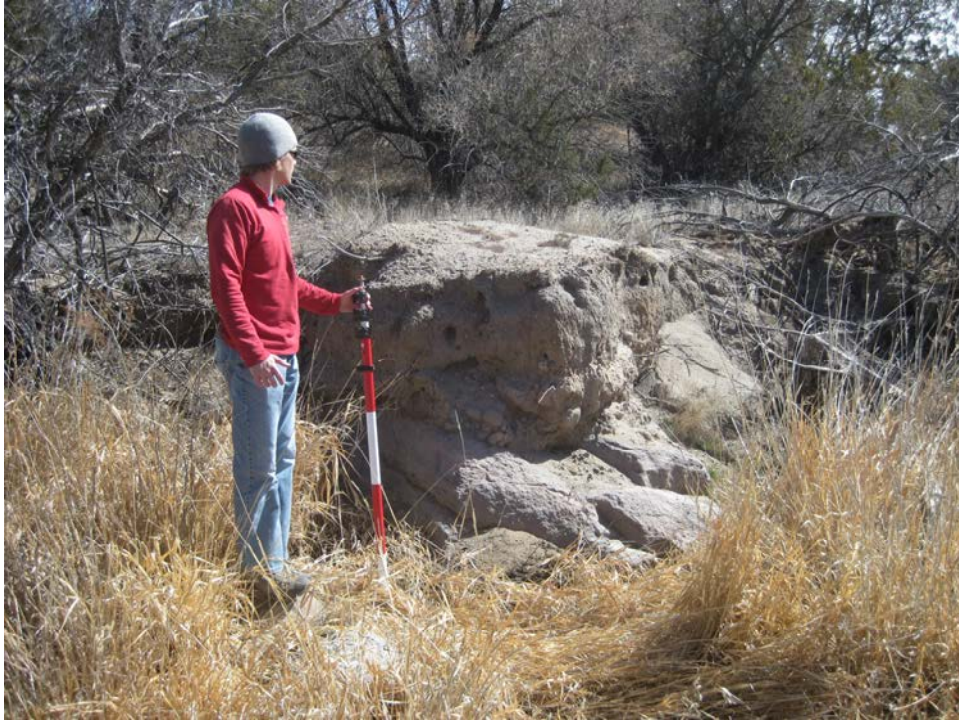
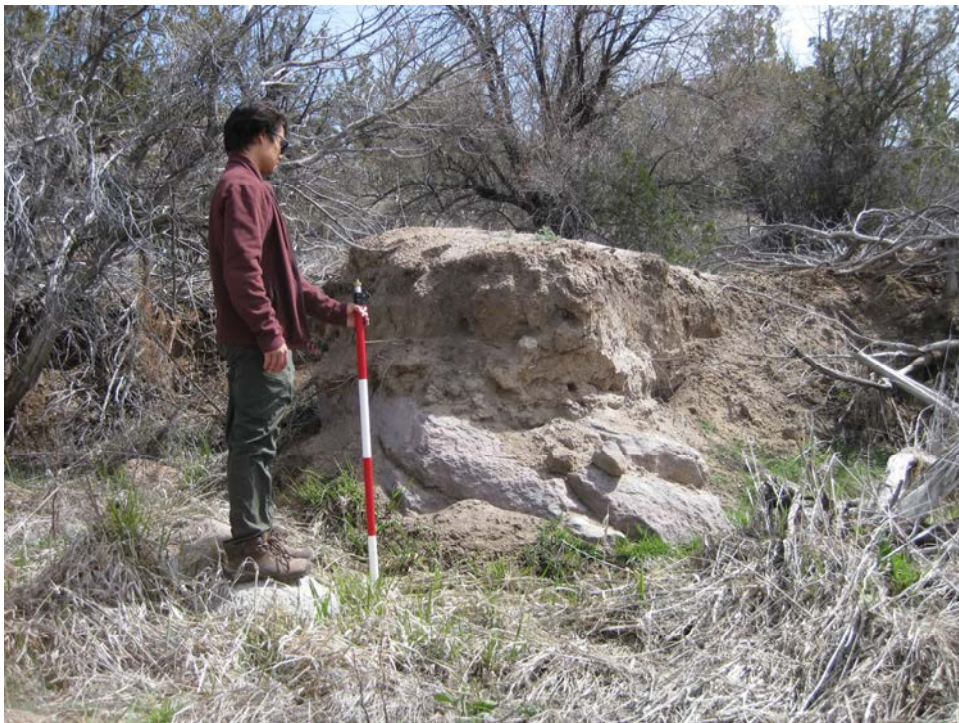
Photo A1-3 Detected erosion (2016) in Pueblo Canyon lower willow planting area in (a) March 2018 compared with the same view in (b) March 2019, showing minor observable change in side channel erosion

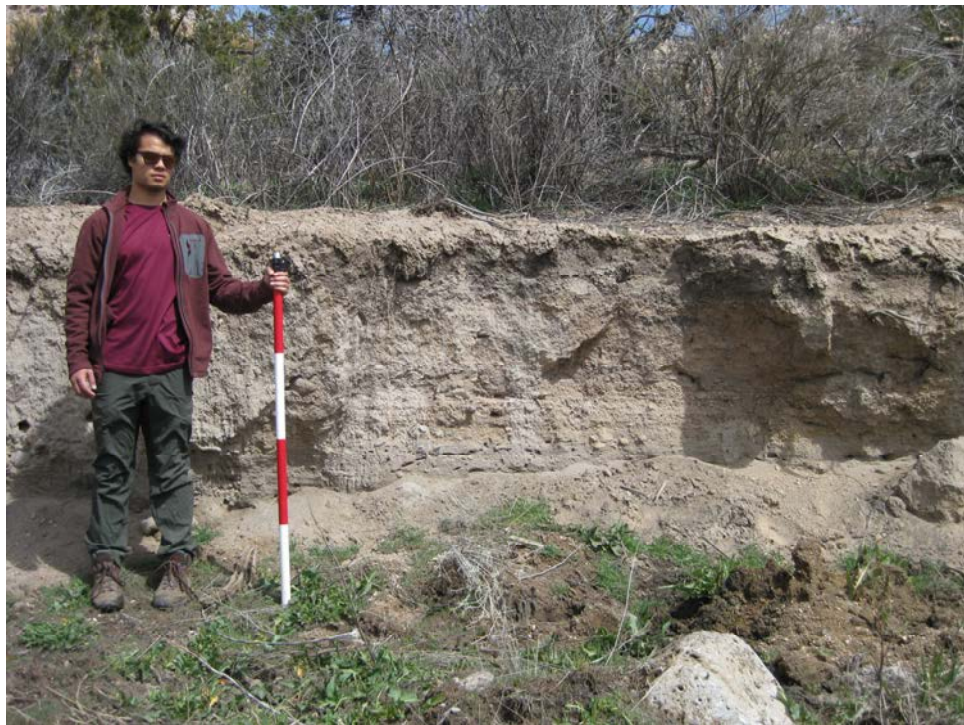
Photo A1-4 Detected bank collapse (2016) in Pueblo Canyon lower willow planting area in (a) March 2018 compared with the same view in (b) March 2019, showing minor observable change

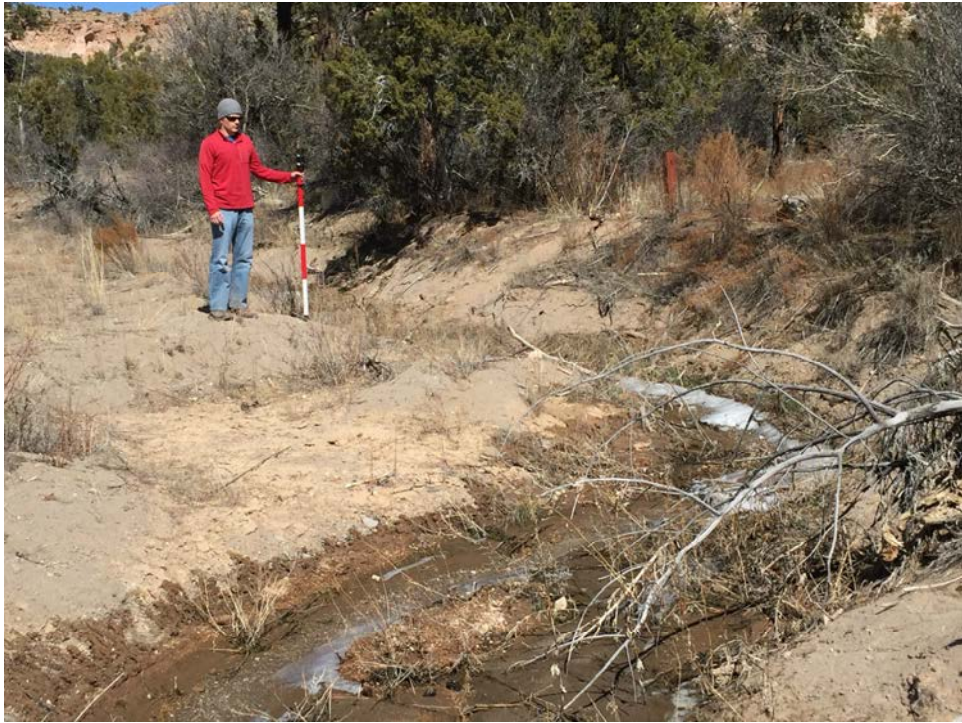
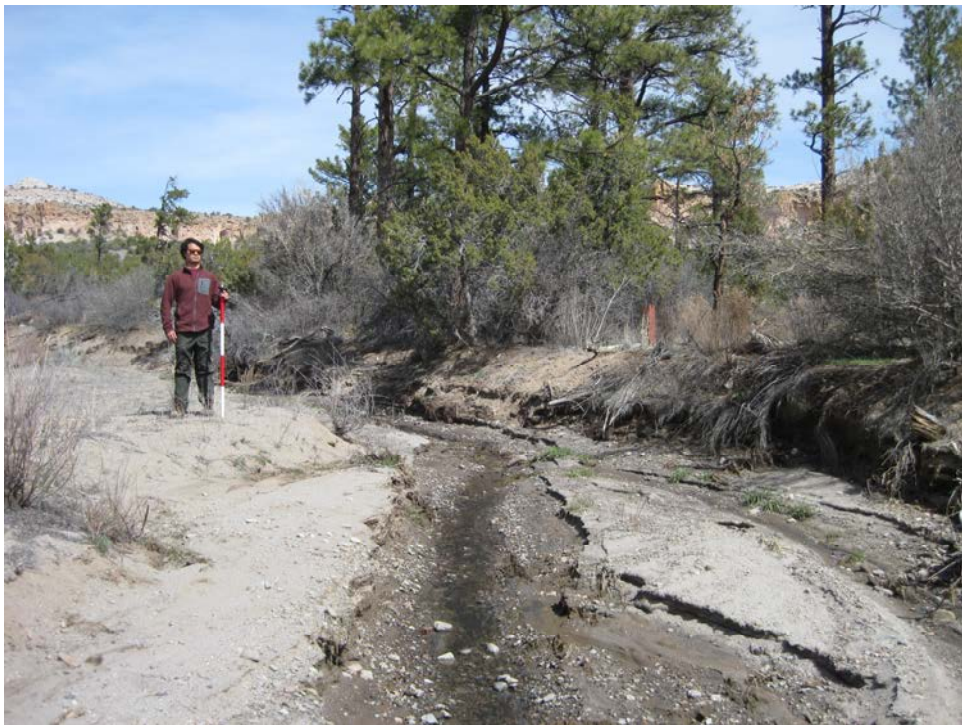
Photo A1-5 Detected incision (2016) near the western edge of Reach P-4C in Pueblo Canyon GCS Area in (a) March 2018 compared with the same view in (b) March 2019, showing post-survey channel incision

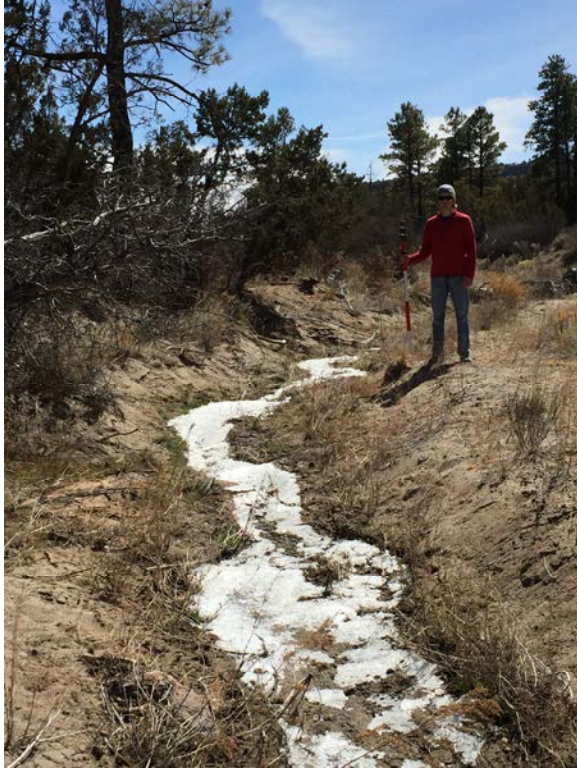
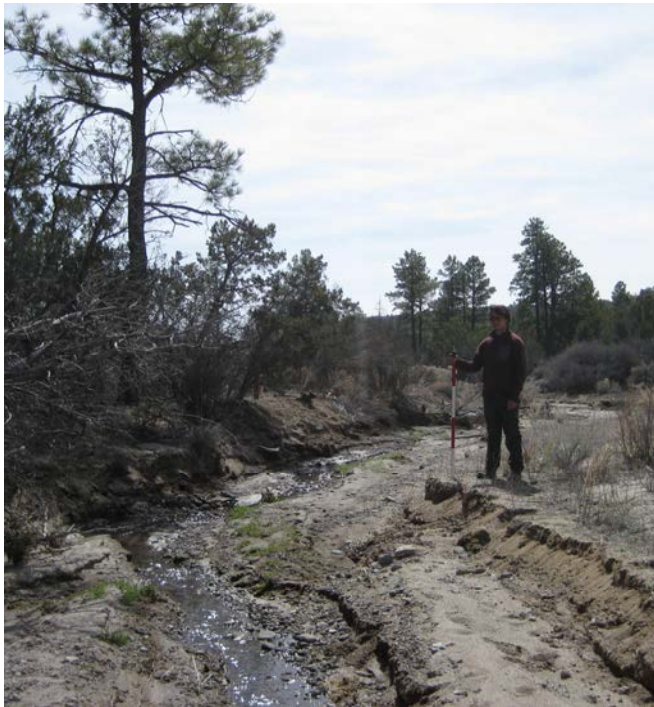
Photo A1-6 Detected incision (2016) near the western edge of Reach P-4C in Pueblo Canyon GCS Area in (a) March 2018 compared with the same view in (b) March 2019, showing post-survey channel incision

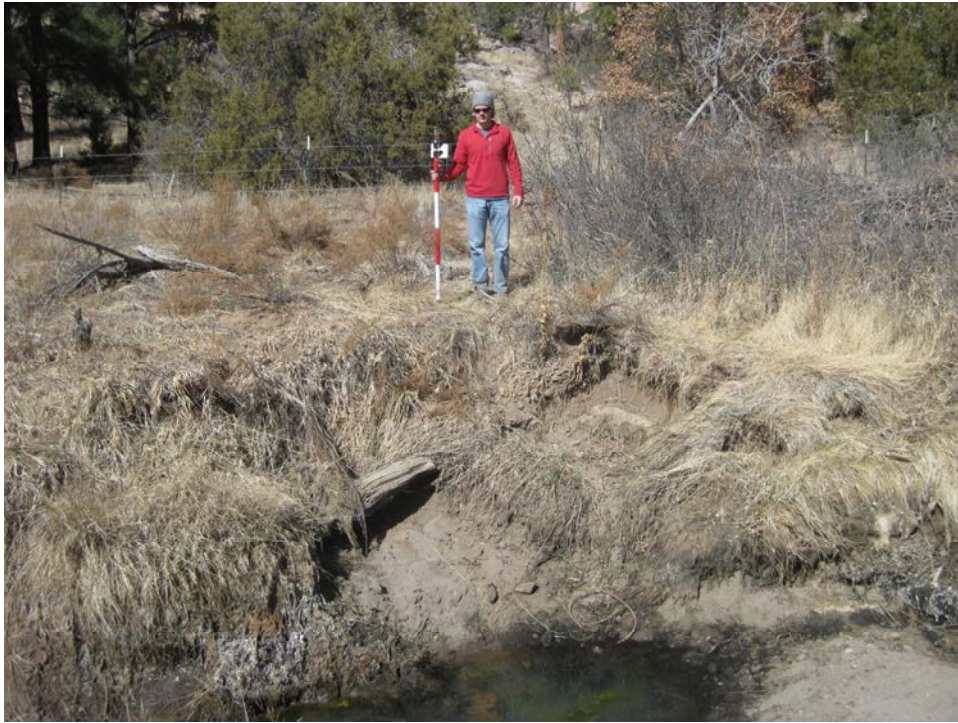
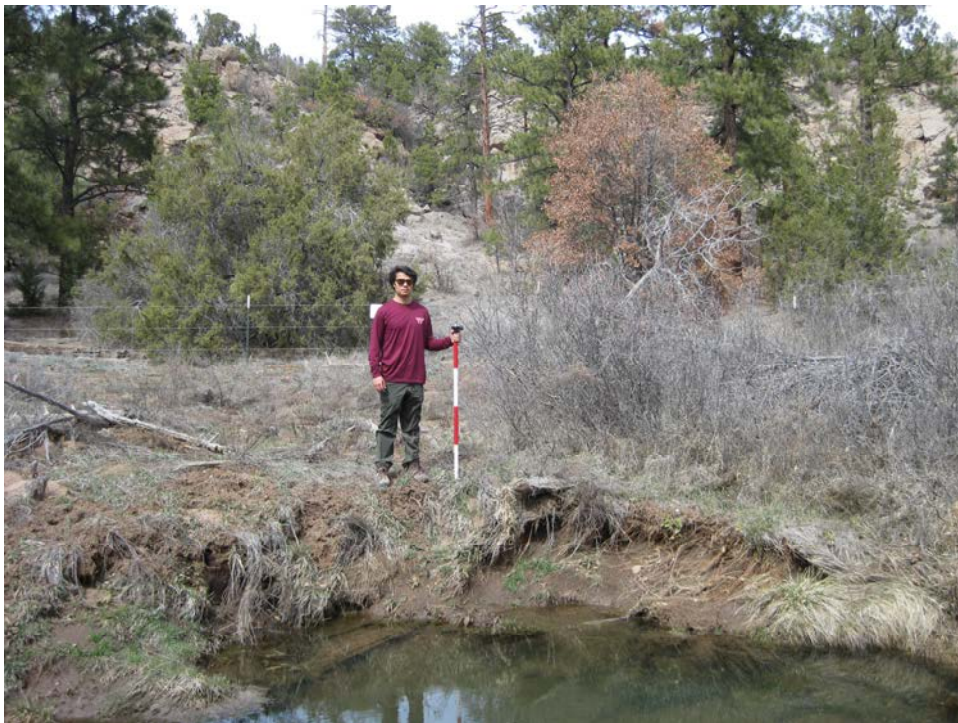
Photo A1-7 Detected bank collapse (2016) above the DP Canyon GCS in (a) March 2018 compared with the same view in (b) March 2019, showing no observable change

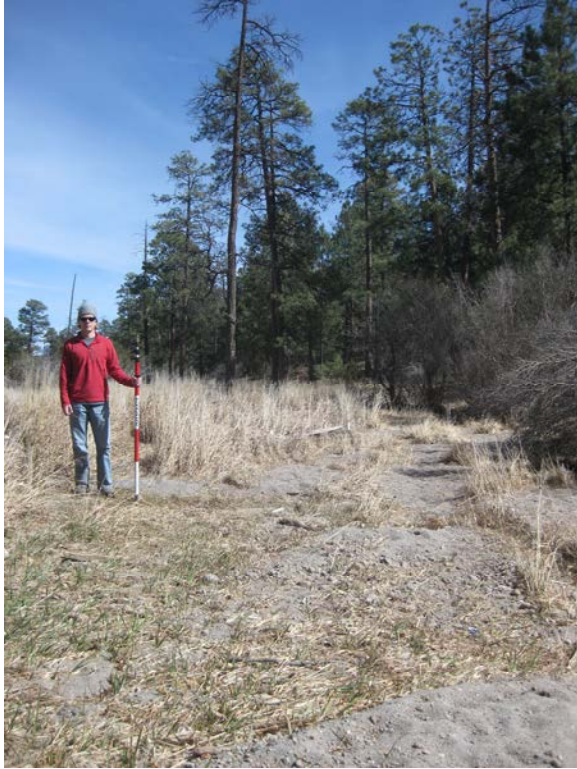
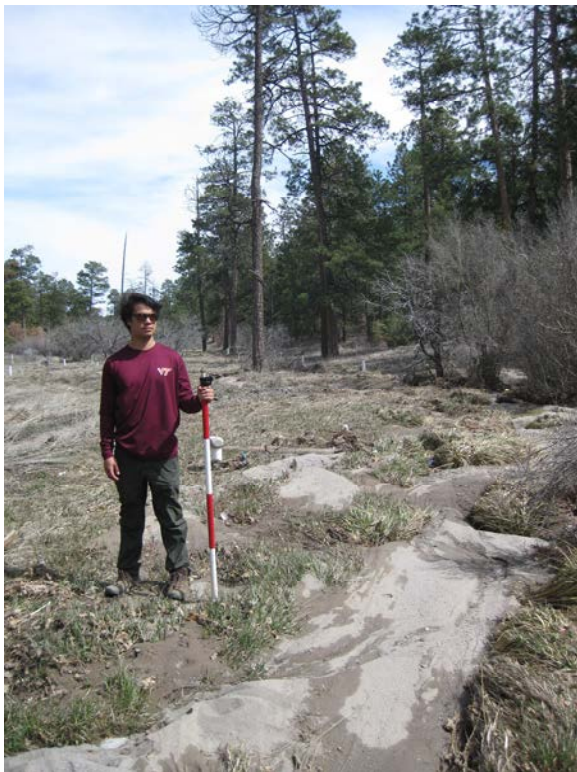
Photo A1-8 Detected deposition (2016) in braided channel above the DP Canyon GCS in (a) March 2018 compared with the same view in (b) March 2019, showing minor observable change

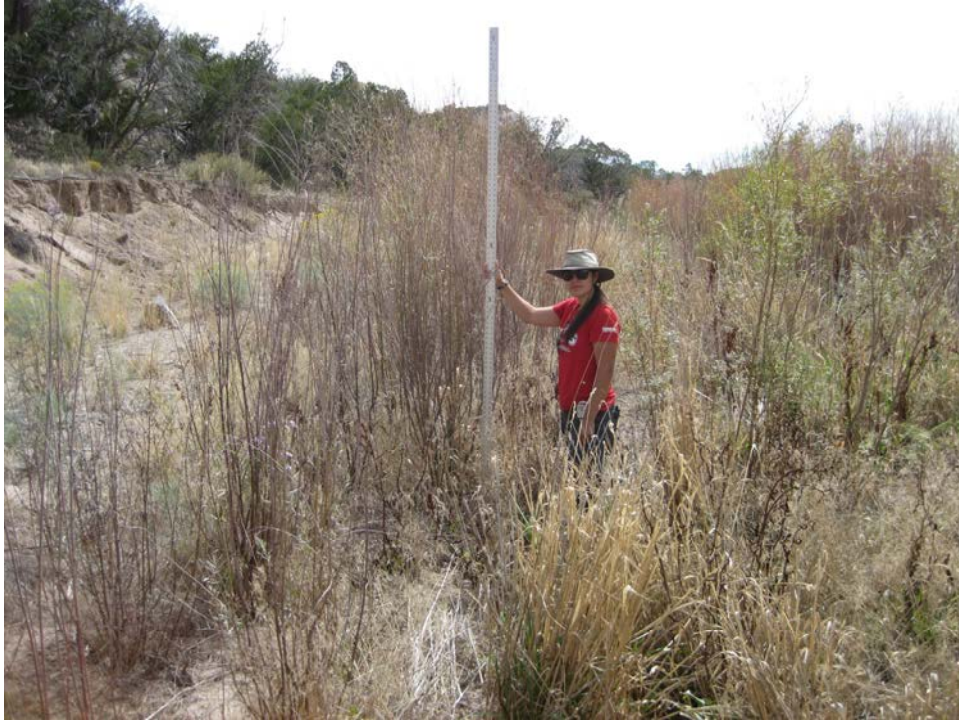
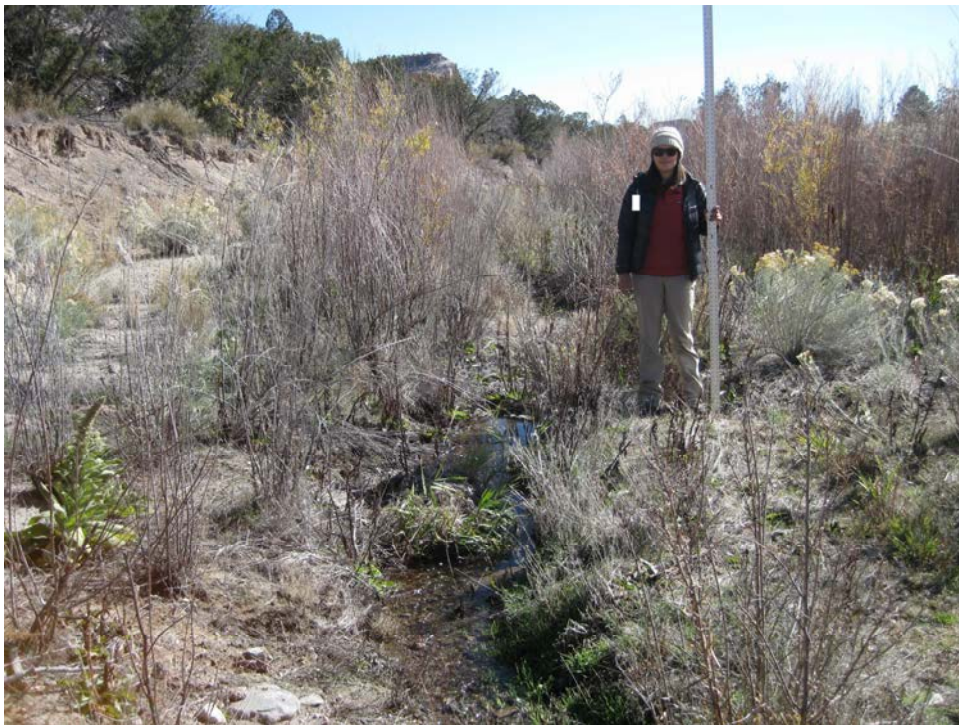
Photo A1-9 Willows planted in tall-height, spatially continuous community (P-5) in 2014 in Pueblo Canyon lower willow-planting area, looking downstream from PU+400, in (a) September 2017 and in (b) November 2018

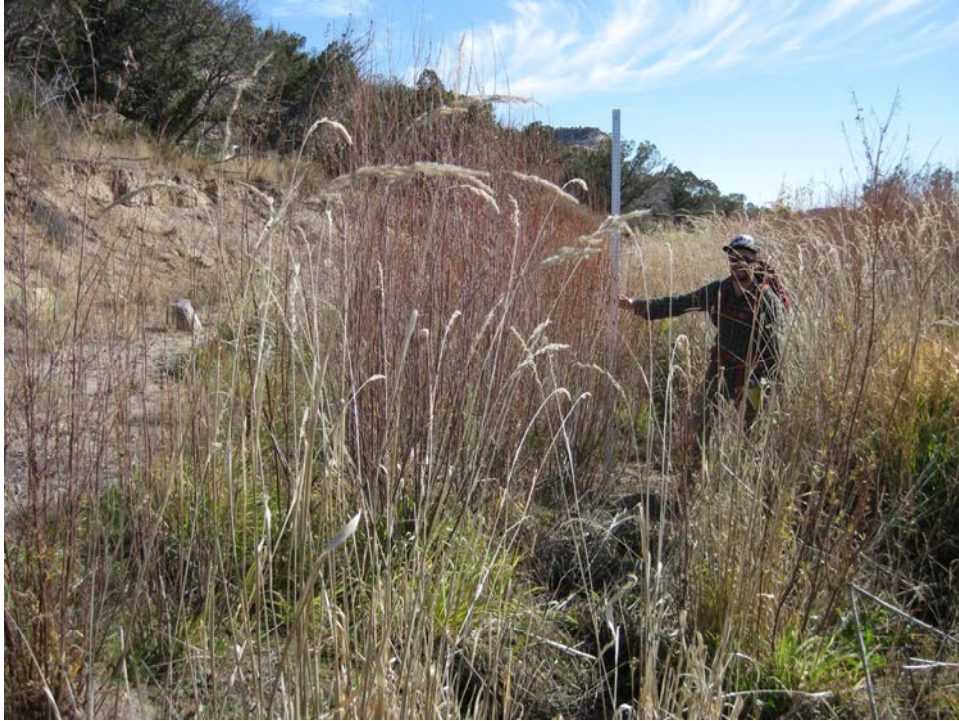
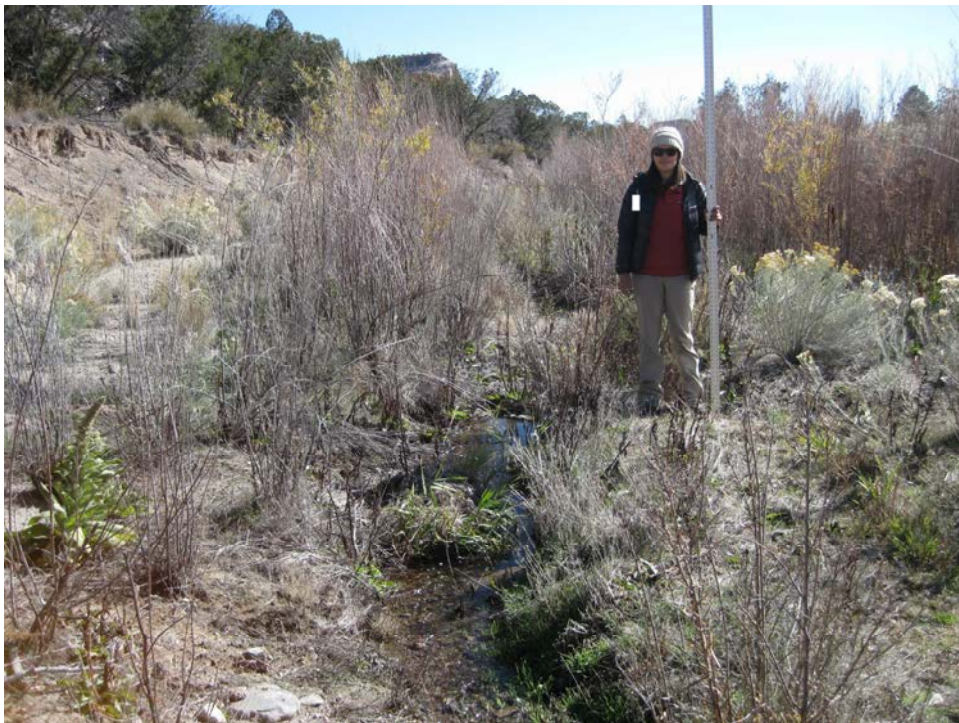
Photo A1-10 Willows planted in Tall-height, spatially-continuous community (P-5) in 2014 in Pueblo Canyon lower willow-planting area, looking downstream from PU+400, in (a) November 2016 and in (b) November 2018

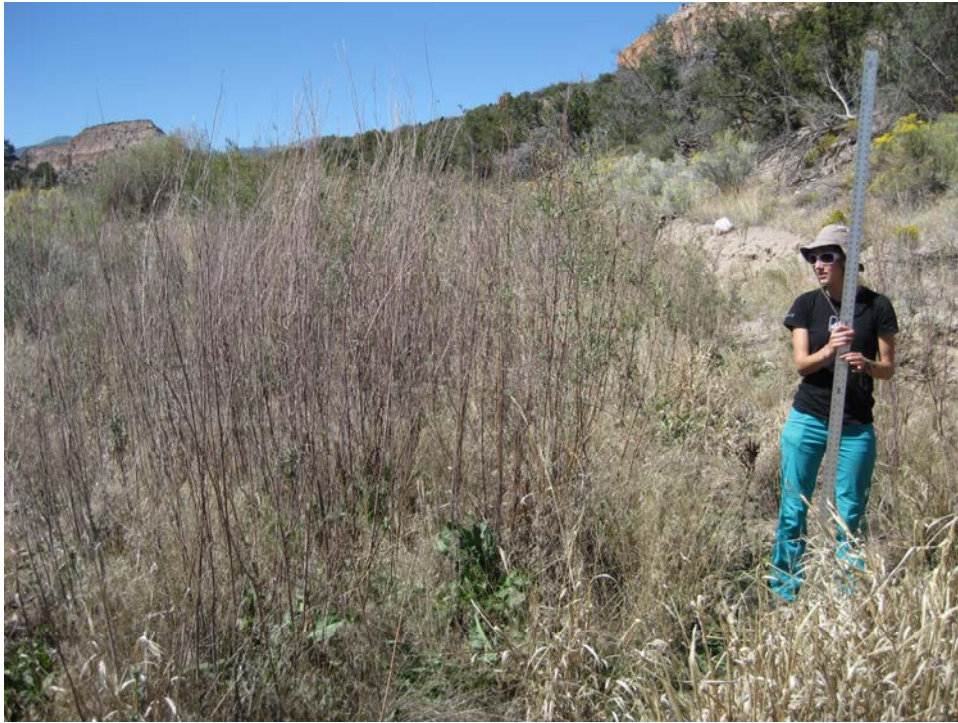
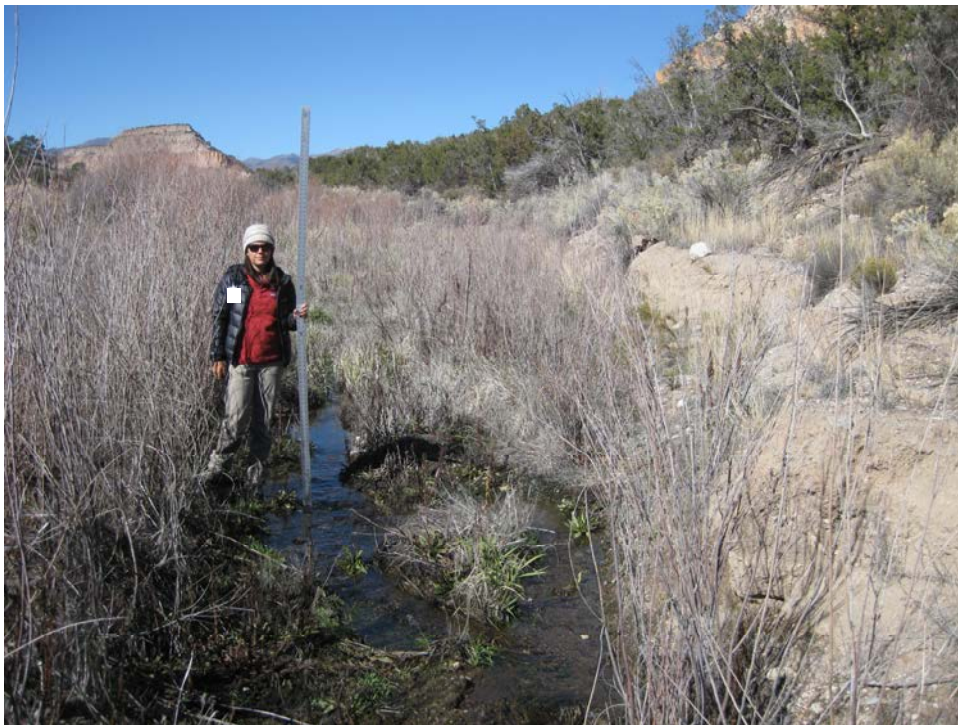
Photo A1-11 Willows planted in medium-height, spatially continuous community (P-4) in 2014 in Pueblo Canyon lower willow-planting area, looking upstream from PU+300, in (a) September 2017 and in (b) November 2018

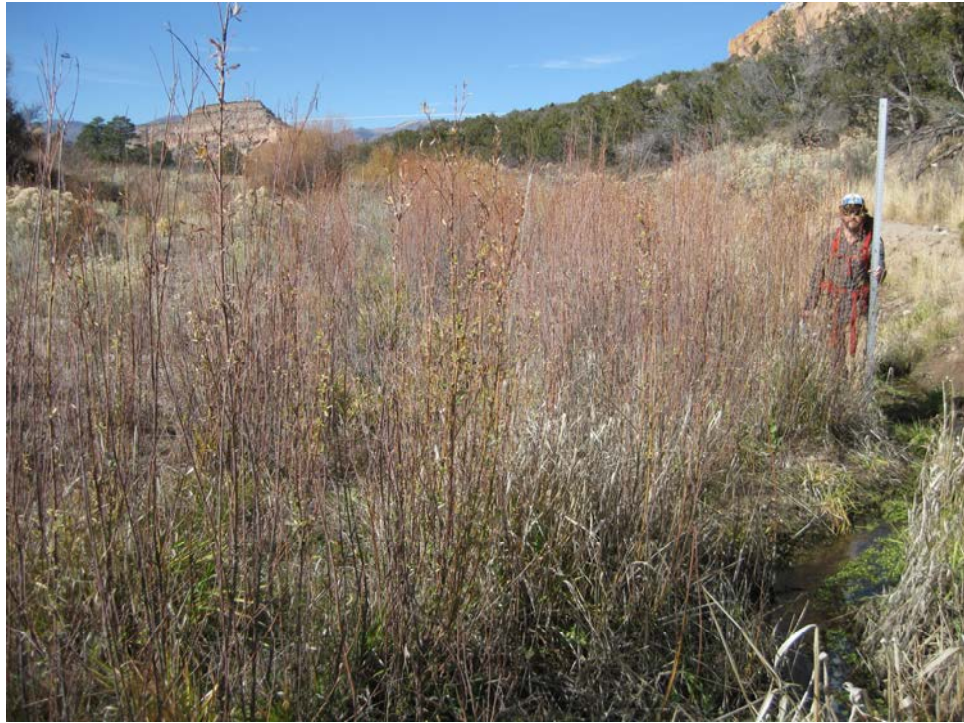
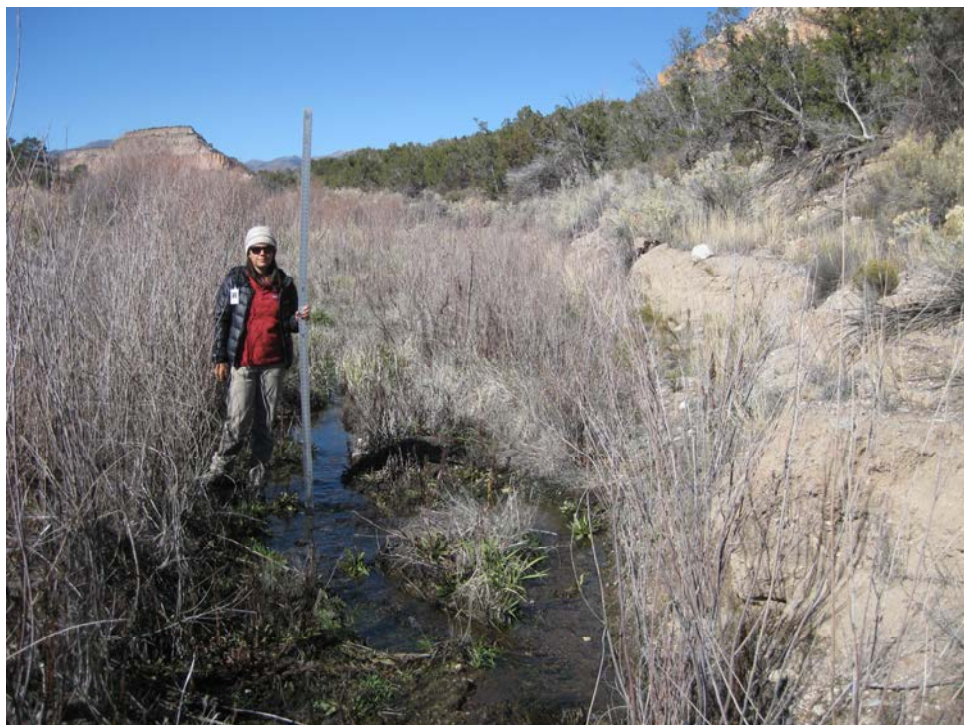
Photo A1-12 Willows planted in medium-height, spatially-continuous community (P-4) in 2014 in Pueblo Canyon lower willow-planting area, looking upstream from PU+300, in (a) November 2016 and in (b) November 2018

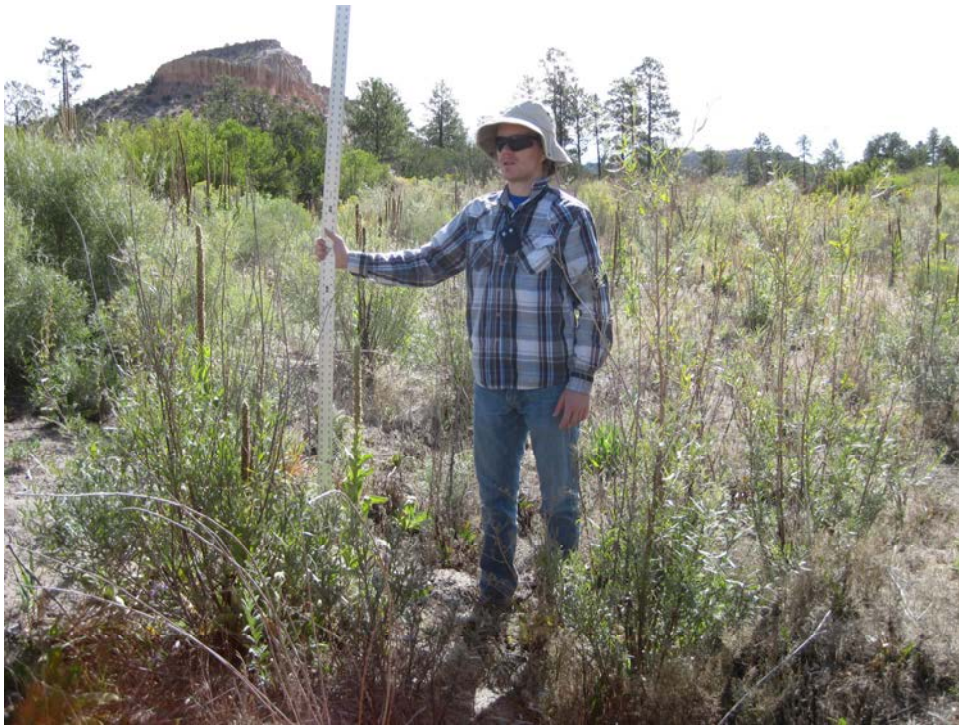
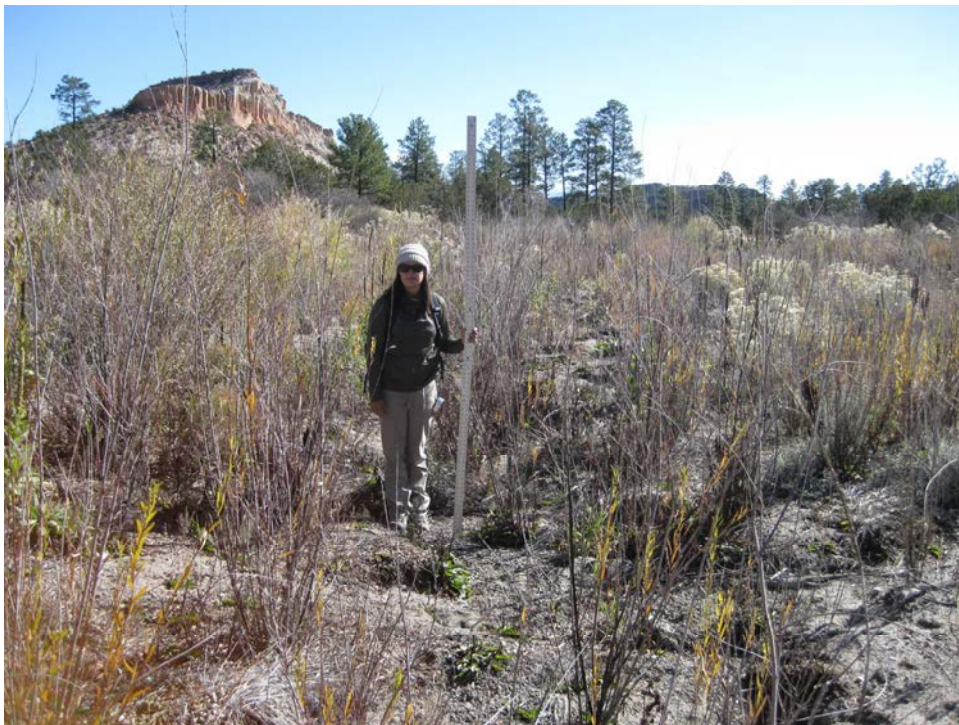
Photo A1-13 Willows planted in medium-height, spatially dispersed community (P-3) in 2014 in Pueblo Canyon lower willow-planting area, looking downstream from P4C+200, in (a) September 2017 and in (b) November 2018

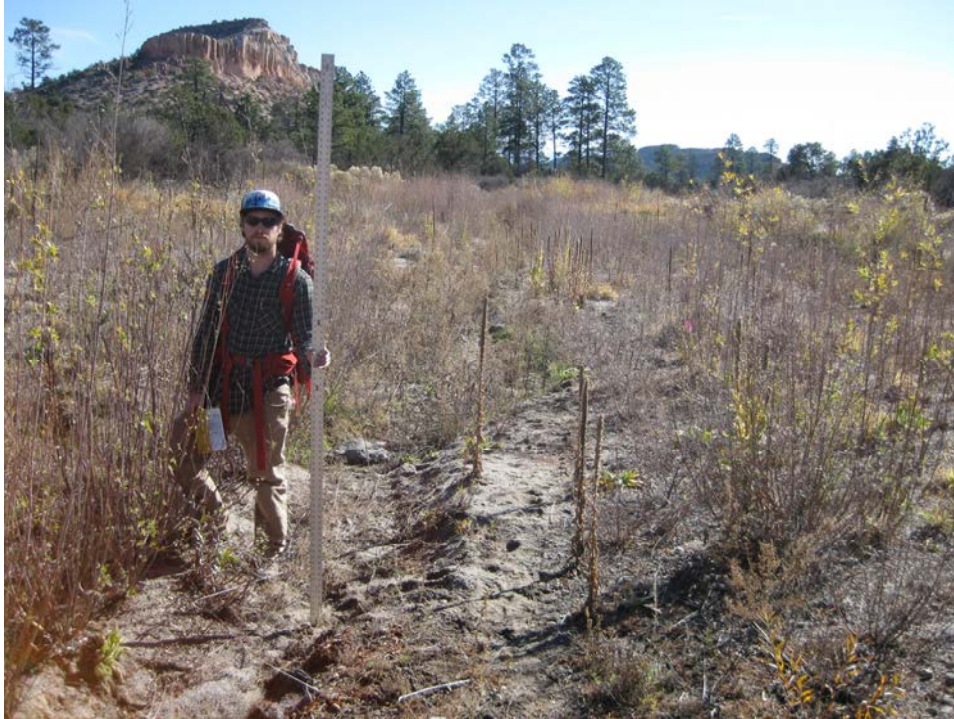
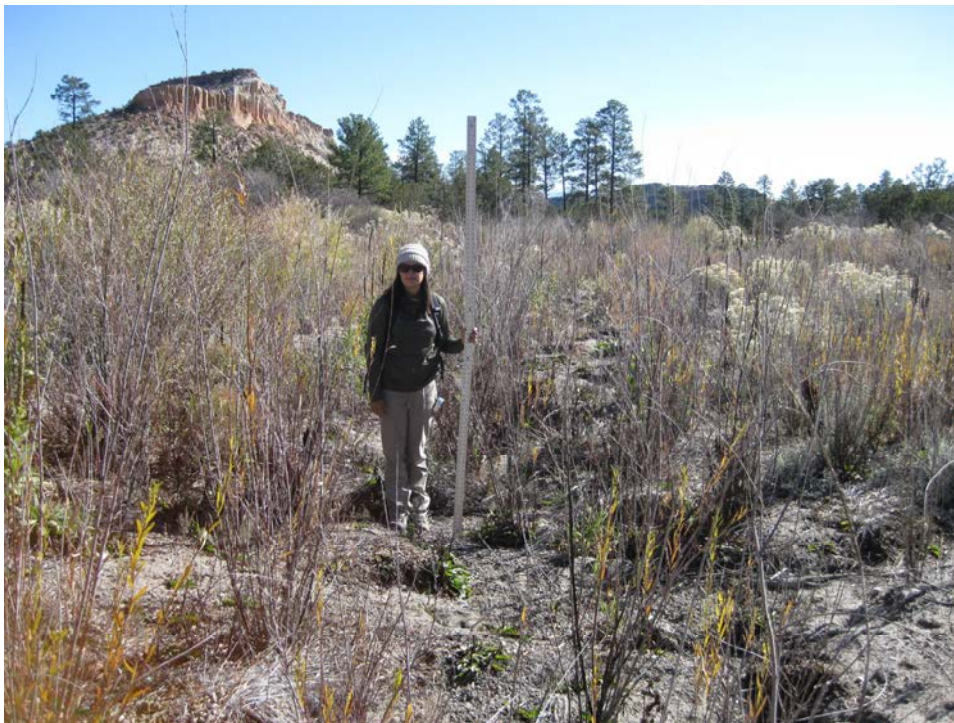
Photo A1-14 Willows planted in medium-height, spatially-dispersed community (P-3) in 2014 in Pueblo Canyon lower willow-planting area, looking downstream from P4C+200, in (a) November 2016 and in (b) November 2018

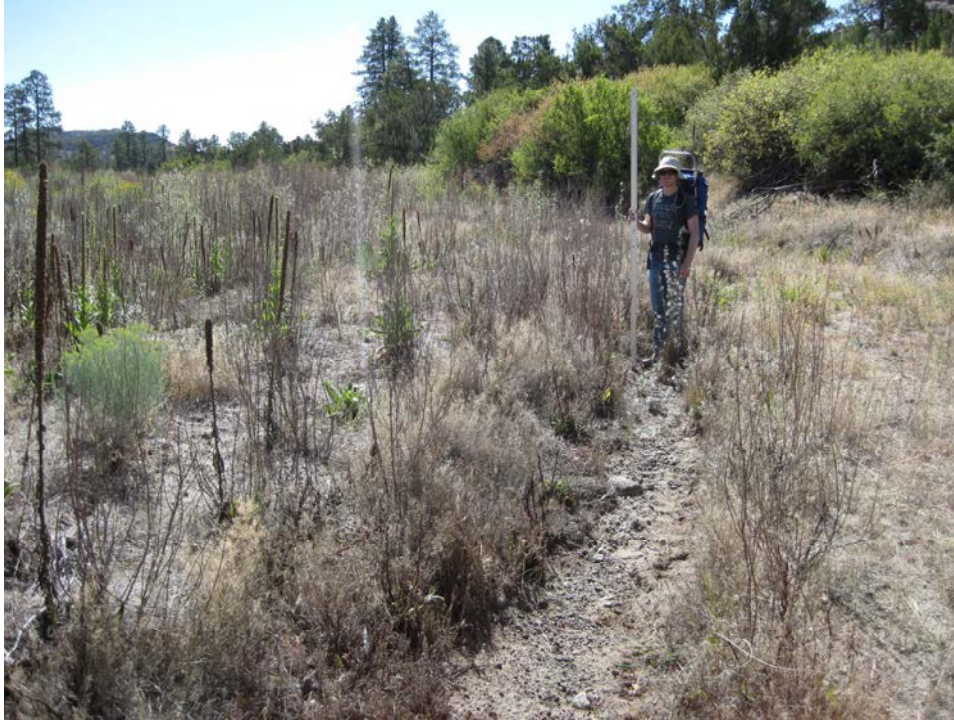
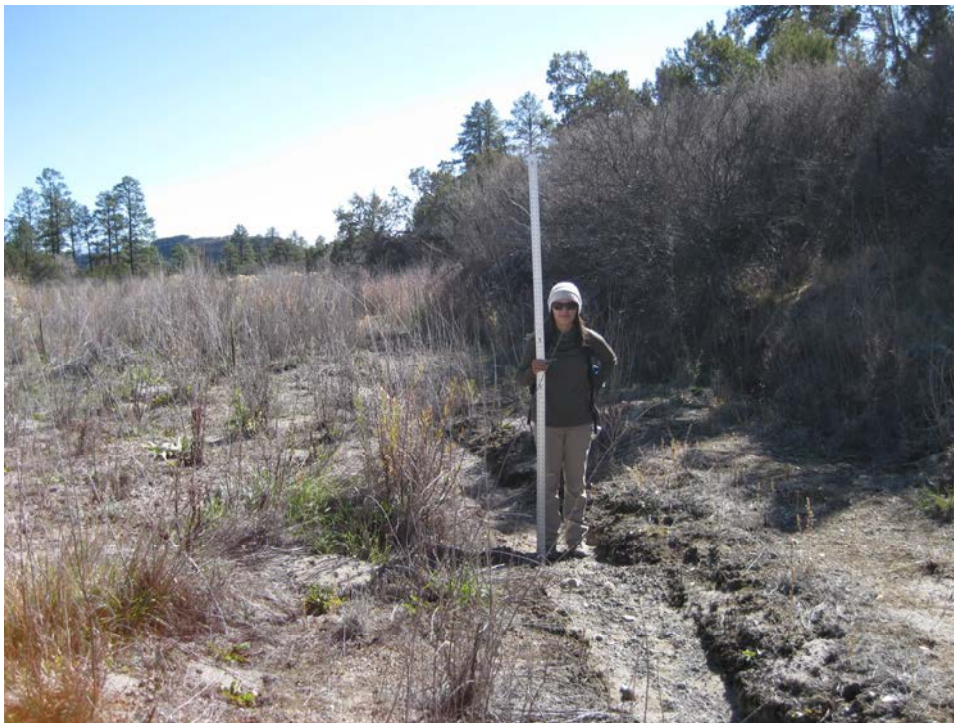
Photo A1-15 Willows planted in short-height, spatially continuous community (P-2) example in 2014 in Pueblo Canyon lower willow-planting area, looking downstream from PU+1100, in (a) September 2017 and (b) in November 2018

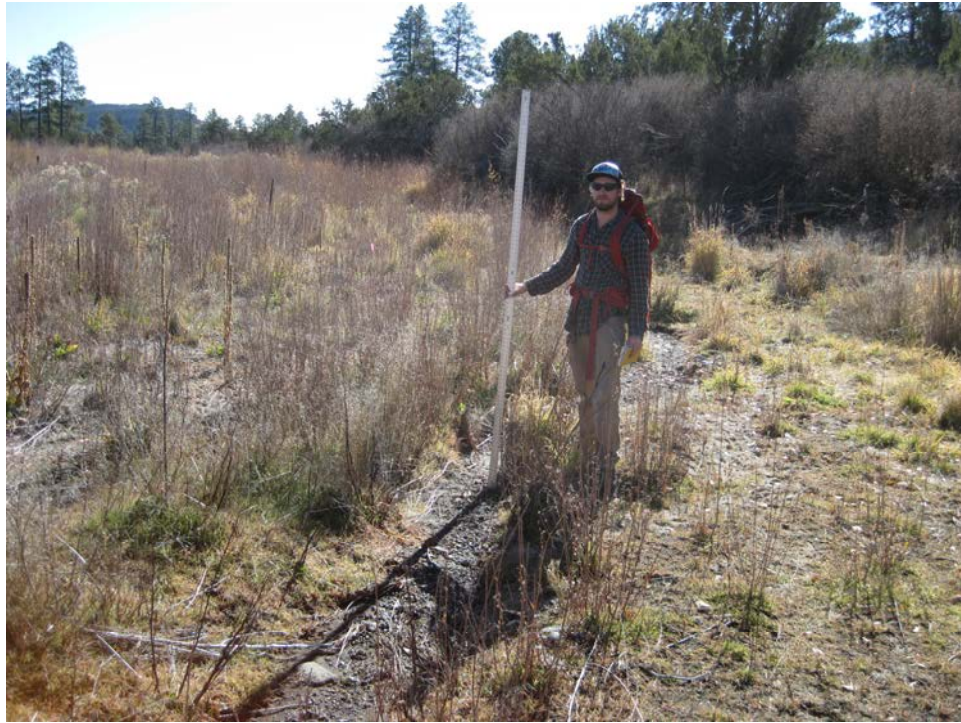
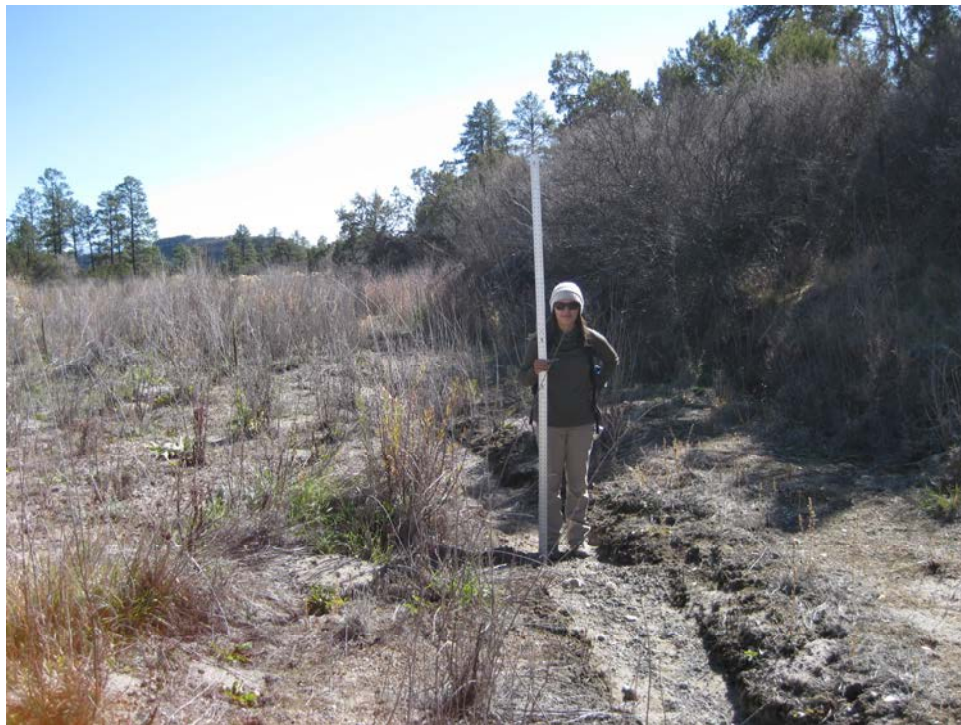
Photo A1-16 Willows planted in short-height, spatially-continuous community (P-2) in 2014 in Pueblo Canyon lower willow-planting area, looking downstream from PU+1100, in (a) November 2016 and in (b) November 2018

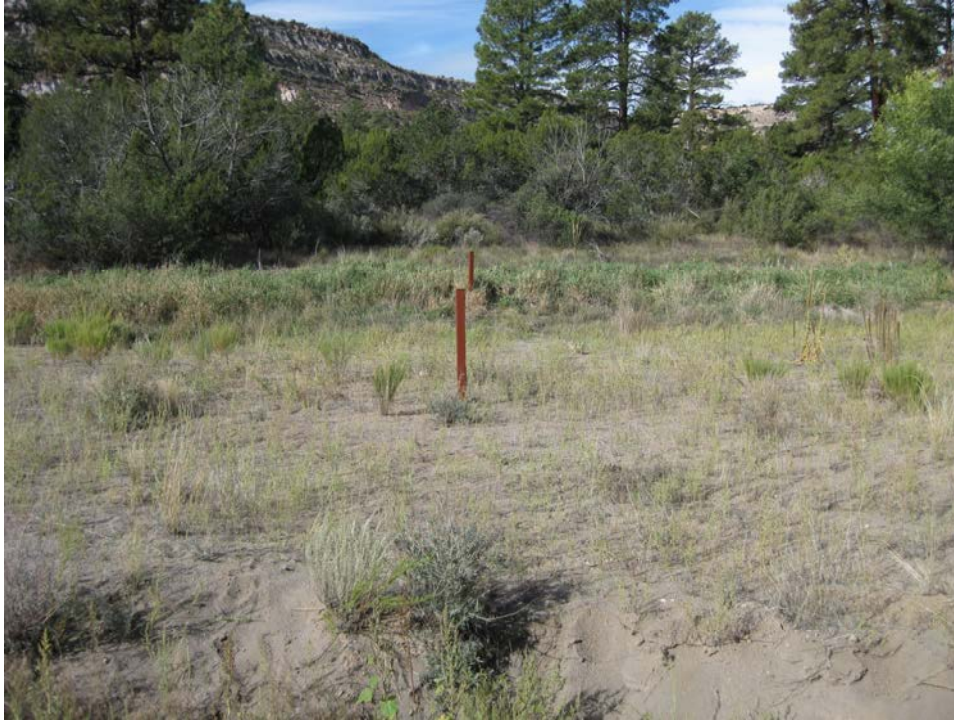
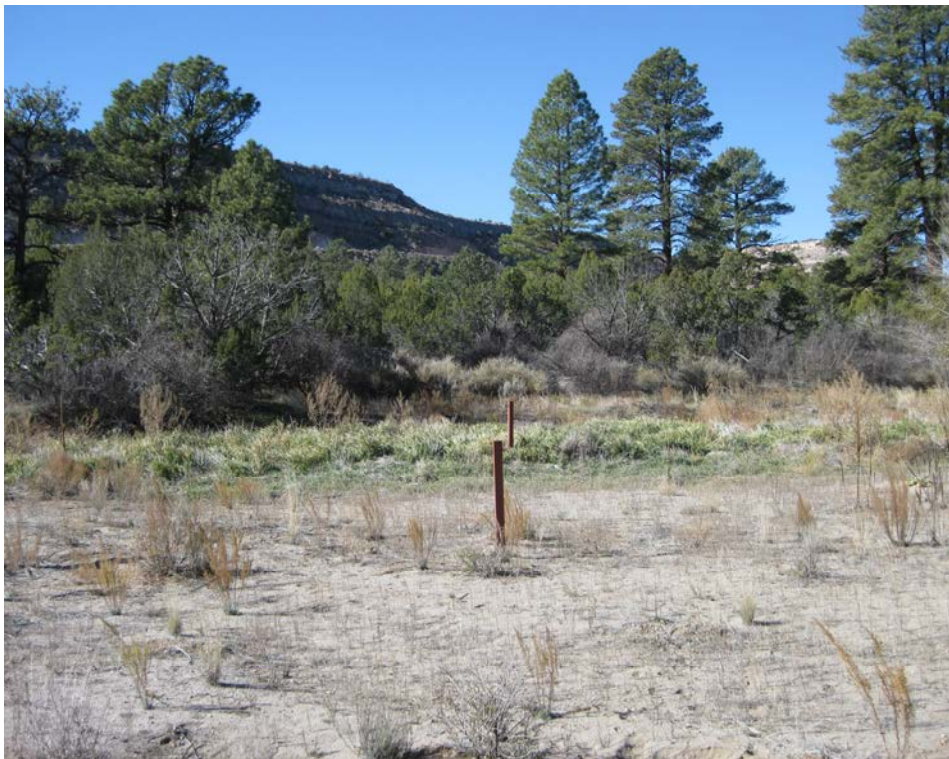
Photo A1-17 Willows planted in short-height, spatially dispersed community (P-1) in 2014 in Pueblo Canyon lower willow-planting area from northern stake at P4C+800, in (a) September 2017 and (b) example in November 2018
